Appliqués for Corrosion Protection in a Tropical Environment

GUY D. DAVIS, *DACCO SCI, Inc., Columbia, Maryland*
TERRY VARGO, *Integument Technologies, Tonawanda, New York*
DOUGLAS DEASON, *U.S. Army Space & Missile Defense Command/ARSTRAT, Huntsville, Alabama*

Appliqués were placed on several structures at the Pacific Missile Range Facility in Kauai, Hawaii. They were periodically inspected and compared to the original paint coatings. The appliqués provided excellent corrosion protection. In some cases, the original paint did not provide adequate protection, requiring either repainting or replacement of the structure.

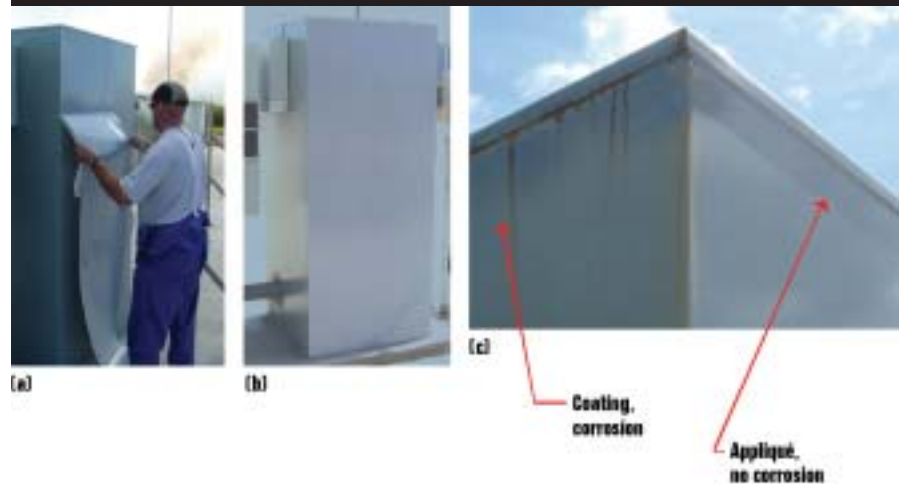
FIGURE 1

Equipment cabinet at launch site. After approximately six months, corrosion had occurred along the edges of the metal sheet. (a) September 2004, applying appliqué, (b) after application, and (c) March 2005.

appliqué (Figure 1). By the time of the first inspection at six months, corrosion on the exposed edges of the roof panel and blistering of the OEM's paint were readily visible, as were rust stains down the sides of the cabinet. An attempt to ameliorate this rust had been made at one point by painting over the rust stains. No corrosion, blistering, or other deterioration were observed where the appliqué had been applied. By April 2005 (approximately seven months after installation), the corrosion was sufficient that a decision was made to replace the original cabinets with stainless steel (SS) cabinets covered by a SS enclosure.

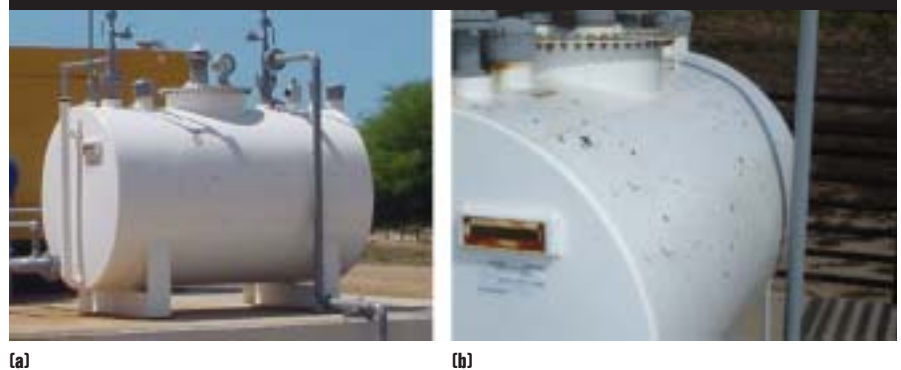
FIGURE 2

East side (mountain side) of storage tank at block house without appliqué. The tank was dirty with bird droppings and rust spots until recoating. (a) September 2004—without appliqué, and (b) October 2005.

The west side (toward the ocean) of a white fuel tank was covered by a white 3-mil polyvinylidene fluoride appliqué; the east side (toward the mountain) was left as received (Figures 2 and 3). The east side quickly became dirty from bird droppings and rust spots where the paint had failed (Figure 2). Because of its appearance and deterioration, the entire tank was cleaned and repainted between the 20th and 25th months. Small spots of corrosion were already beginning to form on the repainted areas. In contrast, the west side with the appliqué remained clean the entire time (Figure 3). Although this side likely received fewer bird droppings than the east side, the non-stick appliqué surface allowed rain to wash

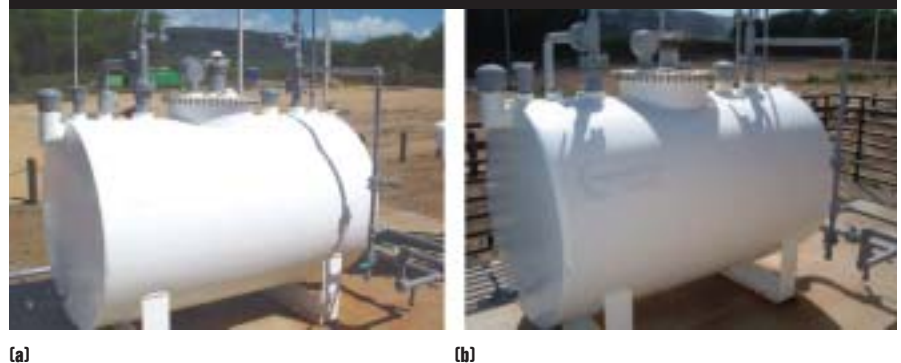
FIGURE 3

West side (ocean side) of storage tank at block house with appliqué. (a) September 2004—appliqué as installed, and (b) October 2005.

the droppings away to maintain a clean surface.
