# Corrosion Protection and Condition Monitoring Using 'Smart' Appliqués

**The tropical marine environment is highly corrosive, and improved corrosion protection and control methods are needed to protect assets and infrastructure subjected to it. One solution to this problem is the "smart" appliqué. The technology, a peel-and-stick fluoropolymer film with a sensor electrode and pressure-sensitive adhesive, provides corrosion protection and condition monitoring to alert an inspector if the appliqué has been damaged or has deteriorated. Electrochemical impedance spectroscopy measurements using the embedded sensors allow condition monitoring. The sensors can detect poor appliqué installation or damage to the appliqué before any damage to the structure occurs.**

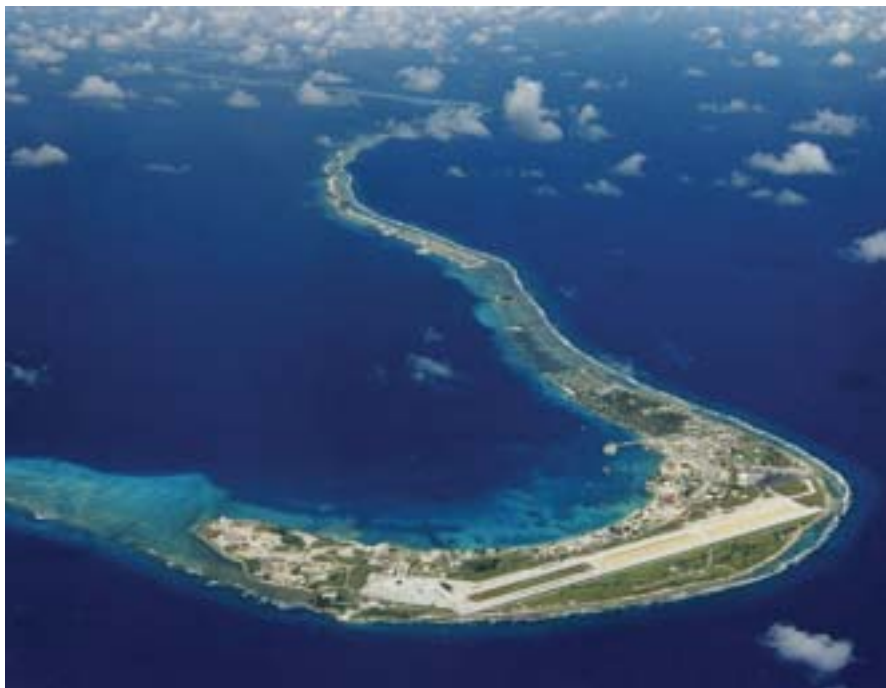
**FIGURE 1**

Aerial view of the Kwajalein Atoll in the Marshall Islands illustrating factors contributing to a high-corrosivity environment: tropical location, proximity of all locations on the island to the ocean, and low elevation providing no wind blocking. U.S. Army photo.

Corrosion is aggravated by the need to operate in some very corrosive environments. For example, MDA has test assets at remote locations at the Kwajalein Atoll in the Marshall Islands in the Pacific Ocean (Figure 1<sup>2</sup>). Critical test assets include radars as well as civil and base infrastructure (buildings, water and fuel systems, and power plants). Such marine locations, especially those in hot climates, are particularly corrosive. The entire island is exposed to a nearly continuous saltwater mist. The facilities' remoteness further exacerbates the situation by limiting the staff available to perform frequent maintenance.

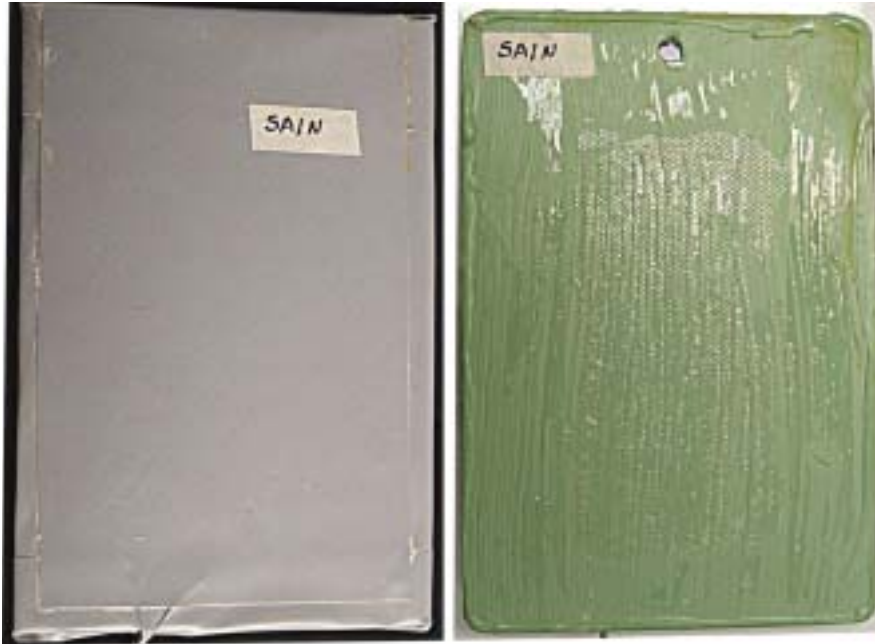
**FIGURE 3**

Example of steel specimens after salt fog exposure before and after removal of no-defect appliqué.

The authors observed no corrosion in the no-defect specimens, including those from which the appliqué was removed to

check the underside (Figure 3). Small amounts of corrosion were seen at some of the back holes but not in others. Moisture ingress via the hole also was detected in some specimens between the appliqué and primer. Rust streaks were observed from the scribed steel specimens; minimal corrosion was seen on the scribed aluminum specimens.

Even with the scribe, there was little undercutting and corrosion below the appliqué. For aluminum panels, the undercutting was <0.04 in. (1 mm). Corrosion of steel panels after 2,000 h of salt fog exposure ranged from <0.04 to ~0.08 in. (2 mm).

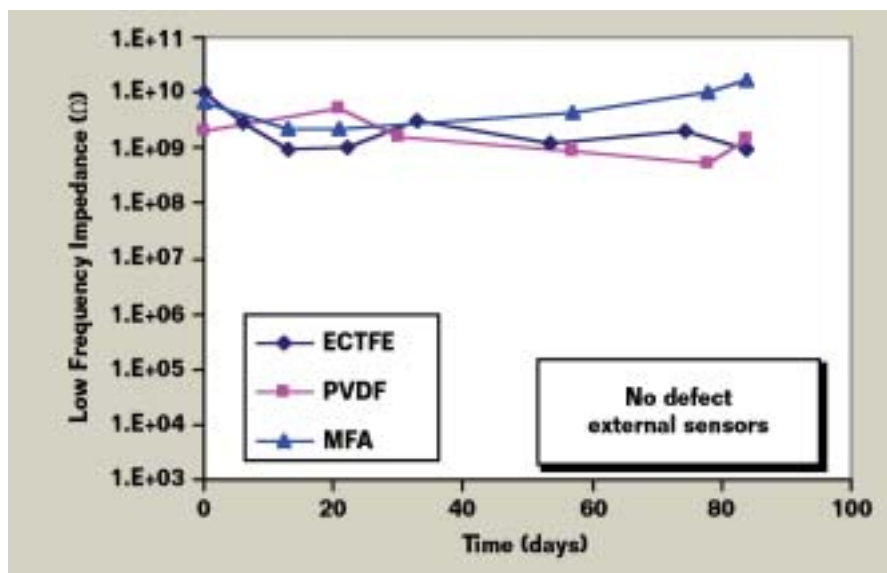
**FIGURE 6**

Low-frequency impedance as a function of salt fog exposure averaged over the three film chemistries. The data were acquired with an external hand-held sensor to inspect the appliqué itself.

The investigators also took hand-held sensor measurements to track any degradation of the appliqué itself. The measurements described above pertained to the primer below the appliqué. One would expect the primer to show signs of degradation before the appliqué would, so it serves as an early warning. Figure 6 shows measurements of the no-defect specimens, averaged over each of the three film chemistries. The impedance remains high for each film with no significant difference among them, indicating excellent corrosion protection with no degradation—a finding supported by the photographs and the internal sensor measurements.
